A Field Investigation of Glacial Lake Outburst Potential in the Taiya River Watershed, Skagway, Alaska

**A Field Investigation of Glacial Lake
Outburst Potential in the
Taiya River Watershed, Skagway, Alaska**

BLM-Alaska Open File Report 99

June 2005

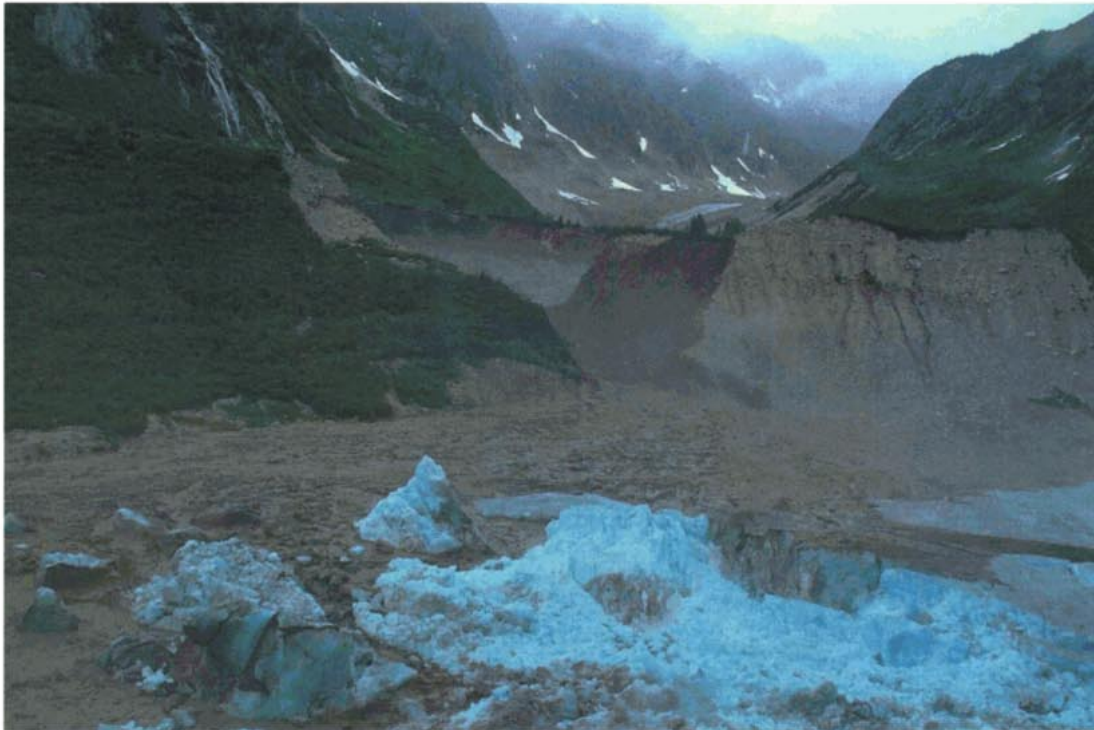
A lateral moraine of West Creek Glacier in the Taiya River watershed near Skagway, Alaska, liquefied in July 2002, causing debris to slide into a glacial lake in front of the glacier's terminus. This event triggered a tremendous flood at Klondike Gold Rush National Historic Park and the community of Dyea, causing extensive damage to bridges, roads and private property. Photos courtesy TEMSCO Helicopters.
