## Tanana Dangerous Ice Report 5-25-2010

Knut Kielland and Bill Schneider are funded under a grant from the National Science Foundation to investigate dangerous ice conditions on the Tanana River. The grant is for three years and the results are to be posted on the Dangerous Ice Jukebox site (Jukebox@uaf.edu). The research area extends from Fairbanks to the village of Tanana. Initial research from Tanana began on March 15, 2010 when Knut Kielland and Karl Olson traveled from Fairbanks to Tanana on the river. On March 16<sup>th</sup> Bill Schneider and Chas Jones flew to Tanana to begin field investigations with Charlie Campbell and Ronnie Evans. The six member crew traveled on the Tanana and on Hay Slough on the 16 and the 17.

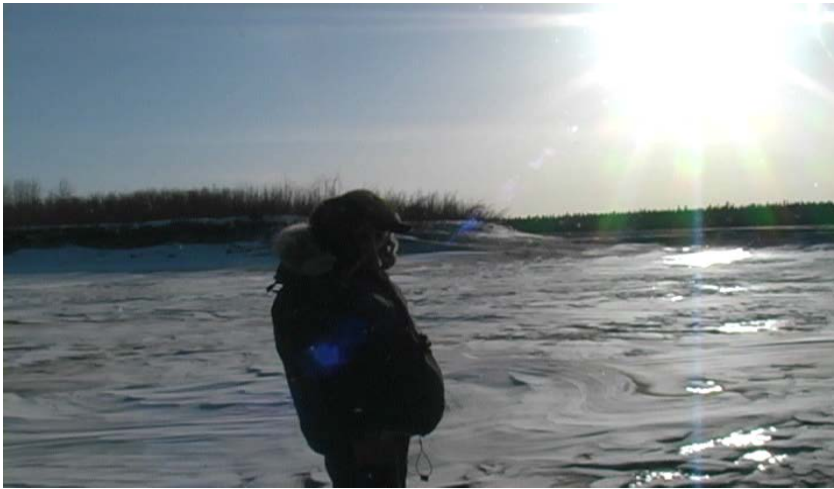
#### Site 1

The first site we visited is listed as GPS 15 (Table 1) on the map (Map 1). This is a place where Lester Erhart went through the ice and is a spot where frequent holes are reported, opens and closes all winter, opens when the temperature warms. *The presence of wind blown sand on the ice facilitates melting. A general caution was expressed about traveling on ice that has sand on it Charlie elaborated by noting that when the sun warms the ice in the latter part of March and April, the dust really hastens heating and melting the ice and rendering it unreliable.*

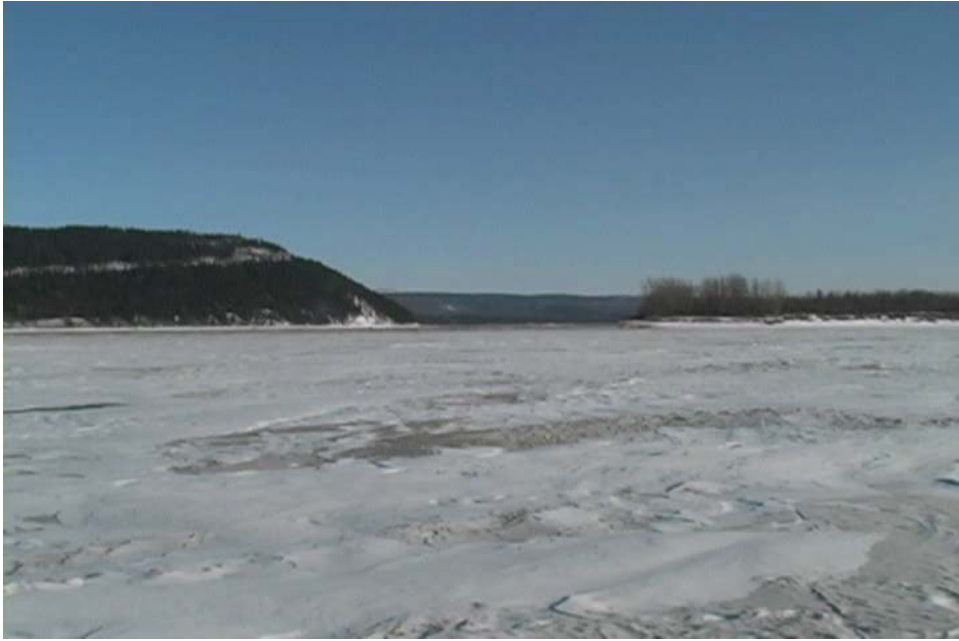
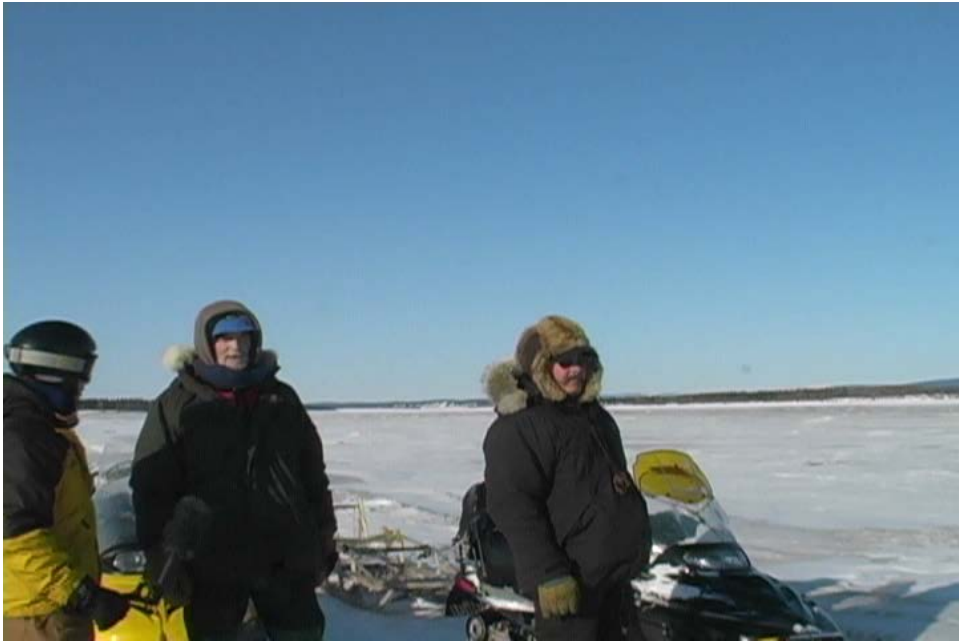
#### Site 2

The second site is listed as GPS 16 on the map and is located straight out from Mission Hill. This is a place that in some winters has open holes and is the reason that the *Yukon River crossing is well above this spot and is marked with willows by community members.*

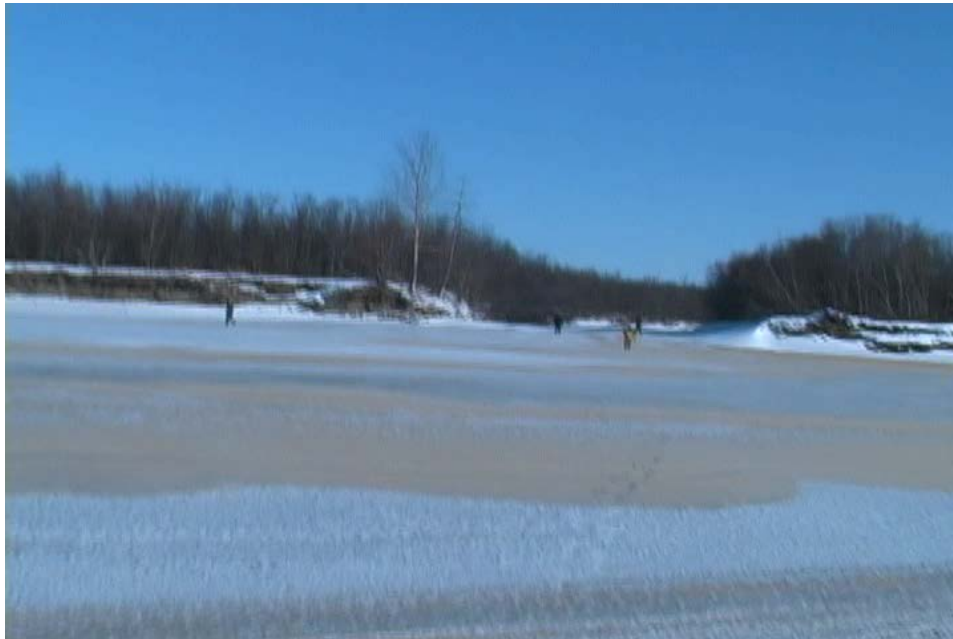
Site 3

The third site is listed as GPS 17 (Table 1) and is located at the mouth of Hay Slough. There is a large overflow outporing that has recently frozen. The slough contains a bulge

in the middle that would seem to indicate pressure. The frozen overflow is dark brown and is both at the mouth and along the sides of the slough. *It was noted that the snow insulates the ice and on the edges of the slough where there is overflow that this could be a bad spot for getting stuck with a snowmachine since the water seeping up could be insulated in normal snow year from freezing.*

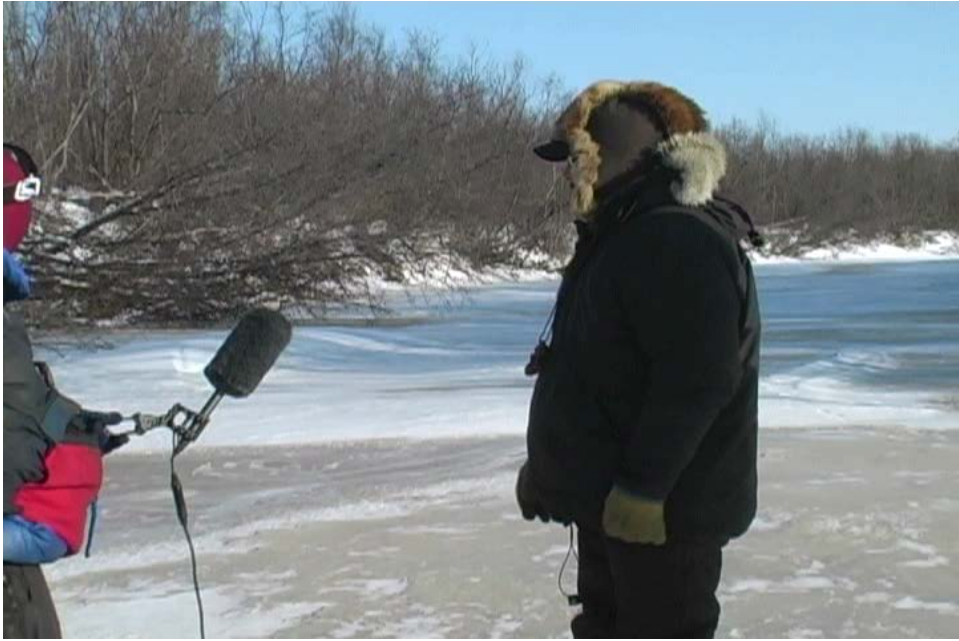
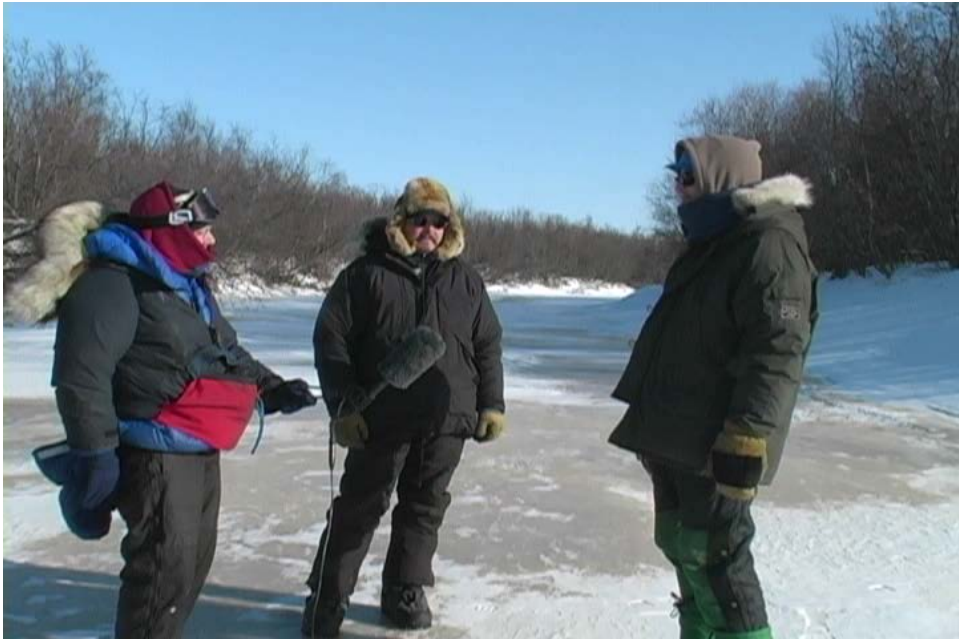
#### Site 4

The fourth site is listed as GPS 18 (Table 1) and is located a short distance up Hay Slough near the portage trail from Hay Slough to the Yukon River. *It was reinforced at this site how overflow occurs after you get snow on the ice and that it is best to stay off the ice till after a good cold stretch. The reason for the portage is to avoid the poor ice at the lower end of Hay Slough.*

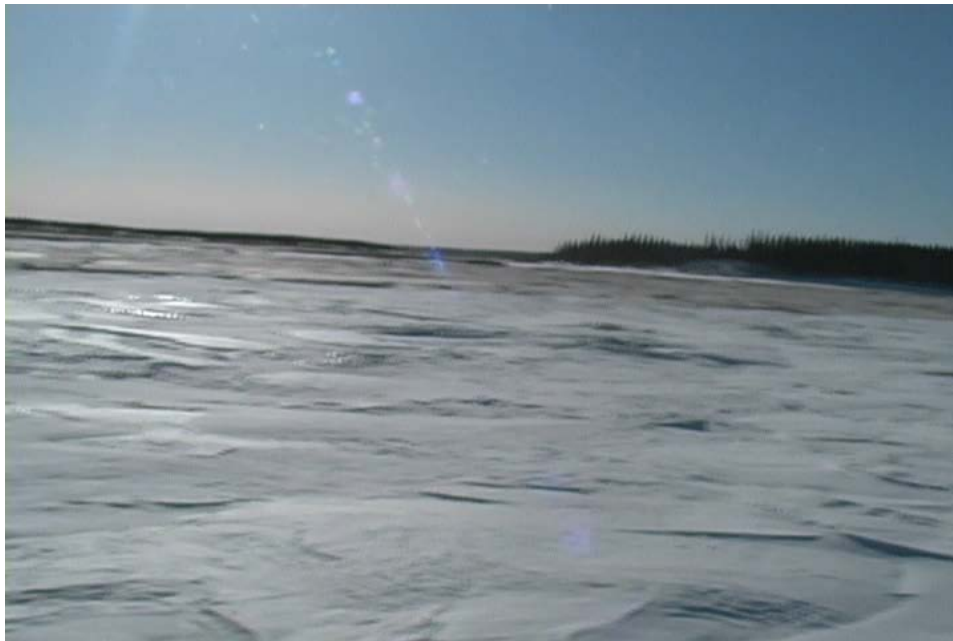
Site 5

The fifth site is located on the Tanana River below Squaw Crossing on the upper end of 8 Mile Island. This is at GPS location [20](#). At this site there was a discussion of river bars

and the cut banks edges. *It was pointed out that when there is lots of snow it is good to avoid these spots because the swift current will be eating away on the ice and the deep snow that accumulates under the cut bank will insulate thereby creating a condition for weak and dangerous ice. Sometimes one can see a snow indent at these spots. It is better to travel on the rough ice where you are assured of safe ice. Ronnie noted that if you have to travel on and off the bars you want to be going at a fast speed so you don't sink. This led to a clarification that one might want to enter and leave the bar slowly so you aren't driving yourself down, but then speed up to pull yourself up onto the flat ice. The idea is to hit the throttle when you are down in the trough, not as you are approaching.*

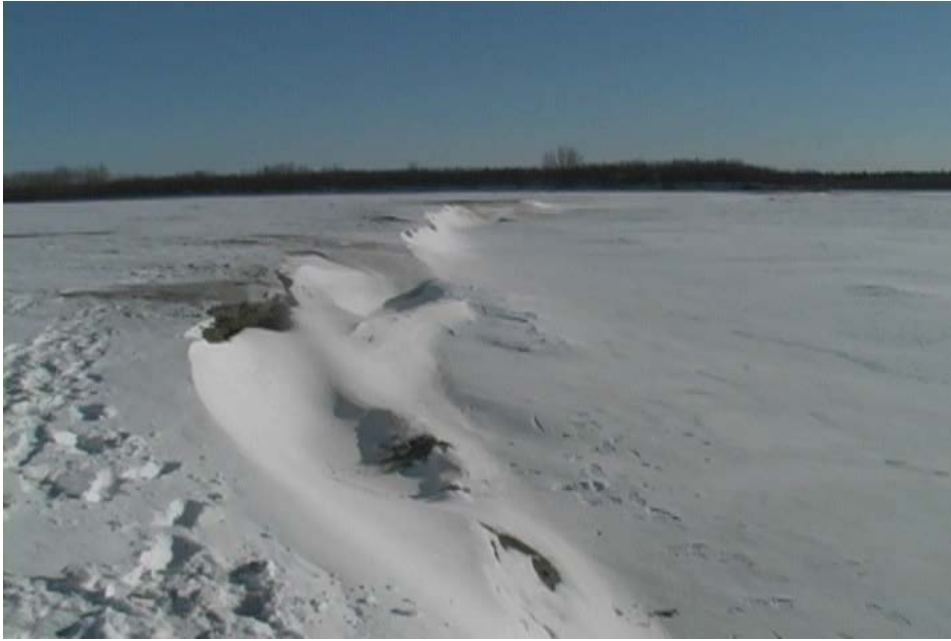
#### Site 6

The sixth site is located on the Tanana River at GPS location 21. *This site has an active cutbank with overhang. The channel has carved its way over this way. This features a Southeast exposure with drifts that insulate. There is also dirt mixed with snow, classic features to avoid. It was pointed out you would want to have a probe if you had to be in this situation. This led to a discussion of the stakes that the iron dog people put in and how one could easily be fooled into thinking the trail was safe and forgetting that trail conditions change frequently and also that those guys are traveling fast without sleds and loads.*

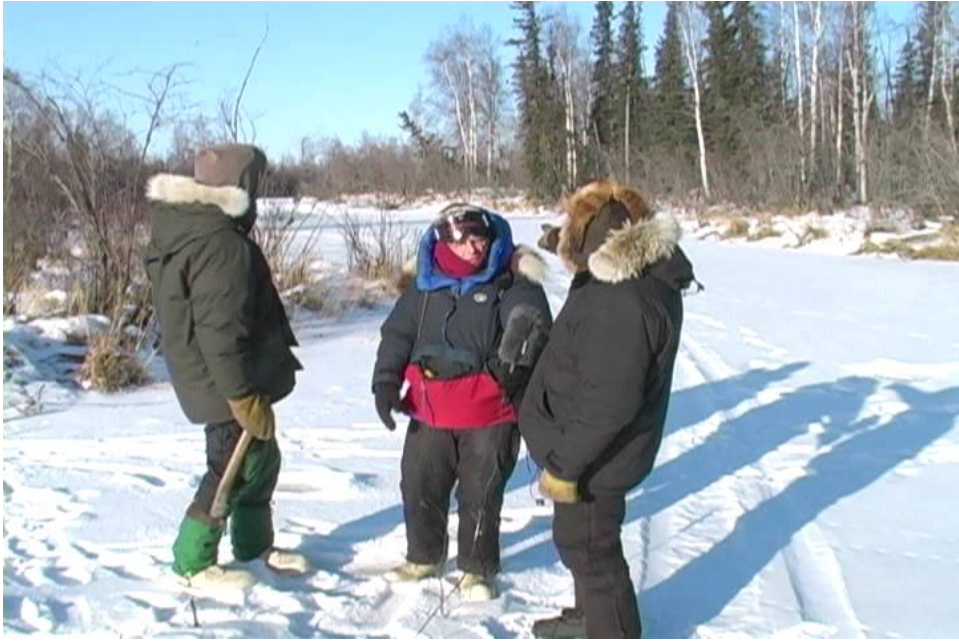
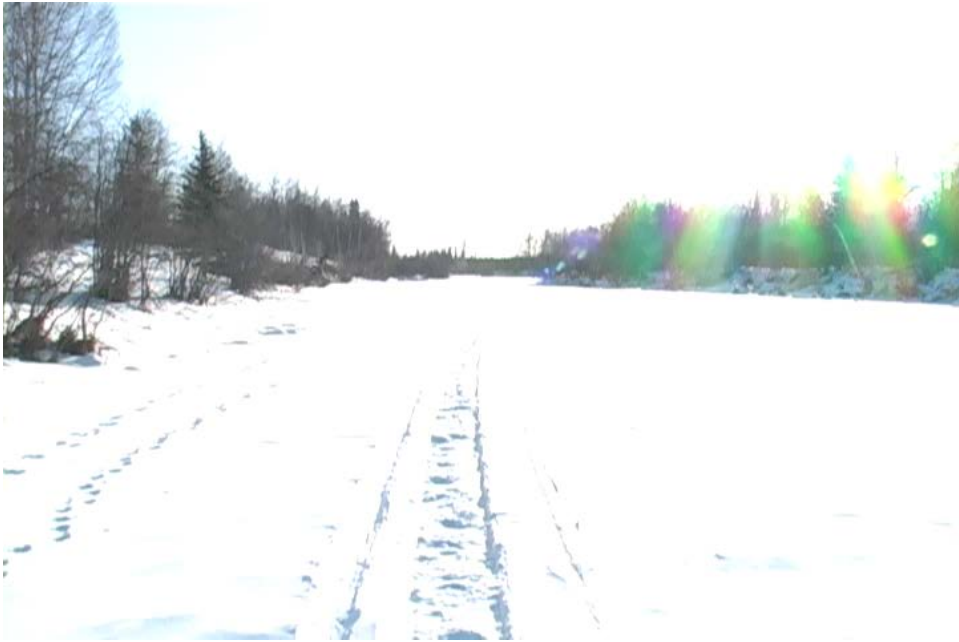
#### Site 7

The seventh site is located up Hay Slough where Jr. Moses and others have fallen through the ice. This is marked as GPS 31. A portage trail has been cut around this bad spot (Fish Creek Portage). The site has been a problem, according to Lester Erhart from as long as he can recall. In a conversation with Charlie Campbell he attributed the problem to thermal action on the north bank. He said that the site opens up quickly when the weather warms up. Ronnie noted that he heard that people used to get winter supply of fish at this spot. The site is particularly dangerous in spring when the temperature warms up. Since this site is on the main overland trail from Manley Hot Springs and is used frequently it would warrant further investigation, scientific monitoring and marking for safety.

Site 7 holds potential for a project engaging scientific testing with local community support. Although there is a portage trail around this specific place, this site is on a section of trail that is often traveled in winter by Tanana residents back and forth from Manley Hot Springs. This is a part of the slough that has a history of open water problems in winter as evidenced in both the cases of people going through the ice here and in the portage trail built around this section of the river. The scientific testing at this site could serve several purposes: determine the cause of the open water, provide information useful to understanding other sites in the slough, involvement of community members in scientific research methods, and such work could build a legacy of shared information in the community and the academy drawing from both the science and local knowledge. This could have positive implications for continuing work on Dangerous Ice in Tanana.

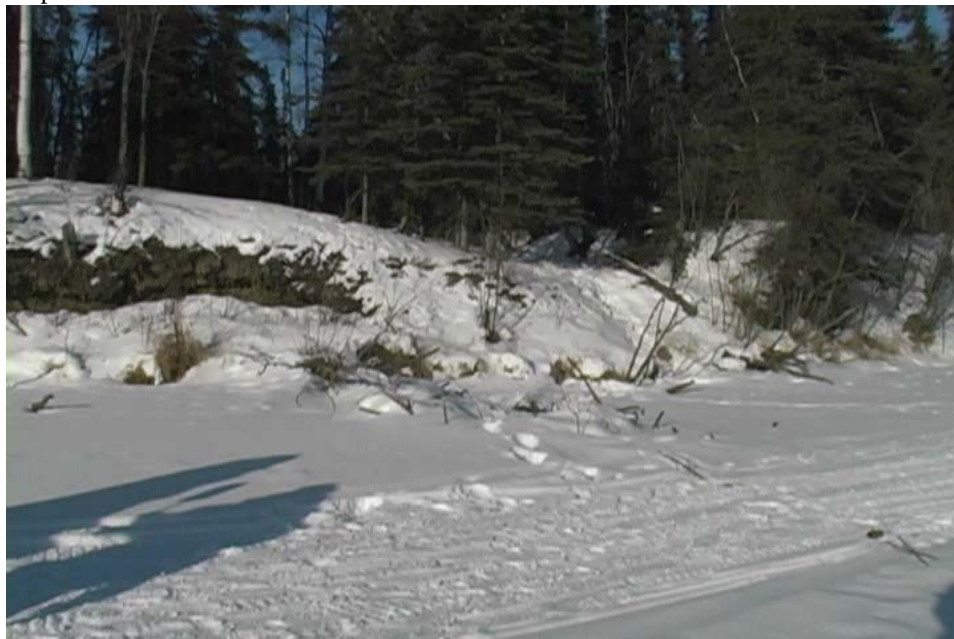
#### Site 8

The eighth site is located further up Hay Slough at a beaver house. This site was open last winter. It was noted that the otters when they hear the water trickling they come and open it up.

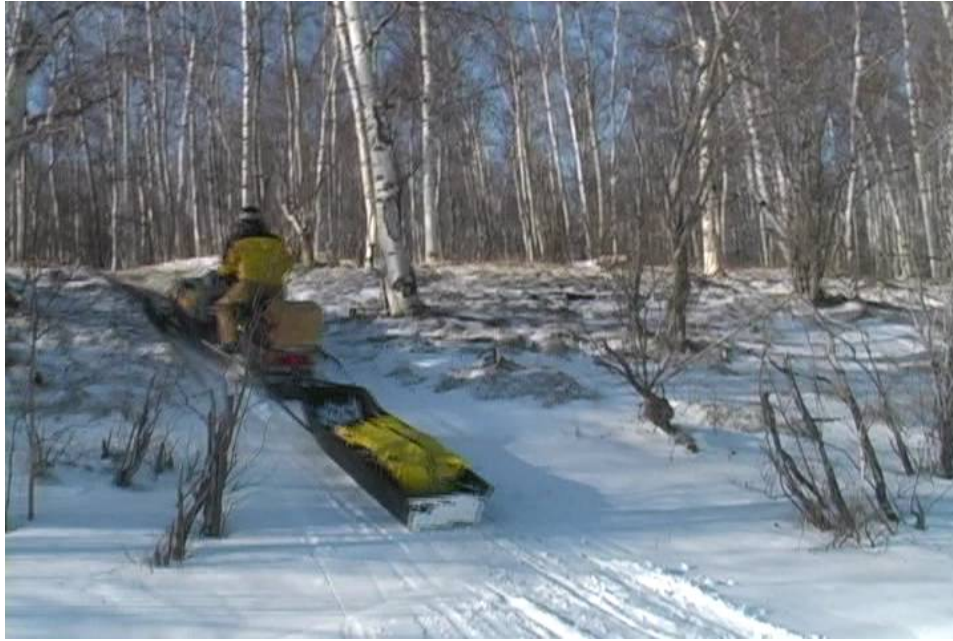
#### Site 9

This is the location of the portage trail around the bad ice spot, site 7. *It was noted that people mark the slough with two branches in an X when the ice is bad and people should take the portage.*
